Type: Airplane Hanger
Location: San Juan, Puerto Rico
General Contractor: Alvarez Trading, Santurce, PR
Dealer: Alvarez Trading, Santurce, PR
Scope: 7,620 m² Maxxon Level-Right WearTop.

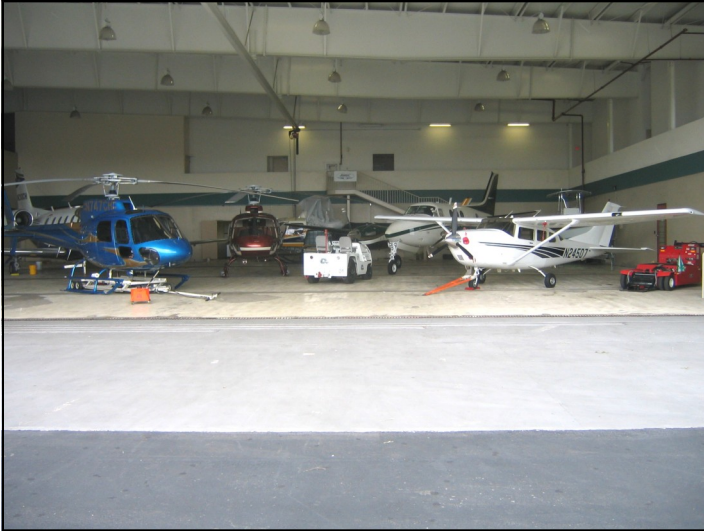
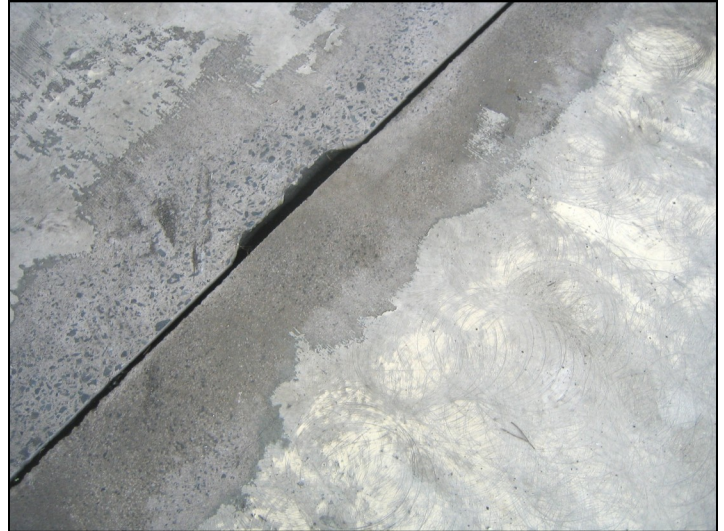
Pictures of the old epoxy floor.

When the old epoxy floor failed in this 7,620 m² hangar, it was removed and covered with 6 mm of Maxxon Level-Right WearTop. The WearTop provided a smooth floor while maintaining a slope to the drain. A chemical resistant sealer was chosen to resist the effects of skydrol spills.

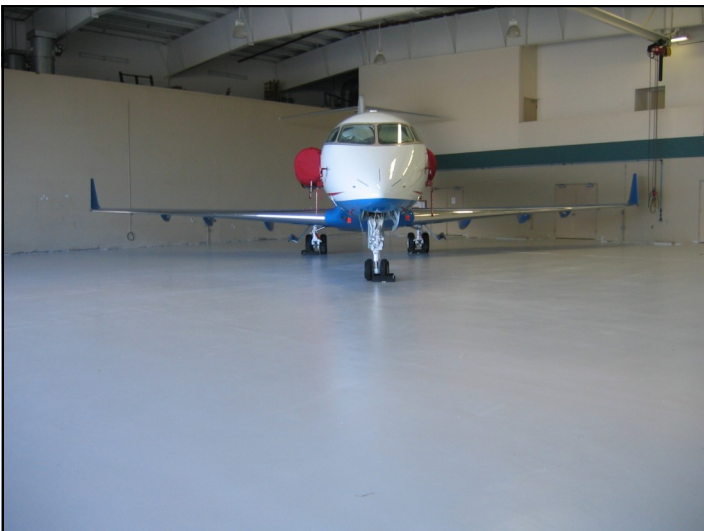
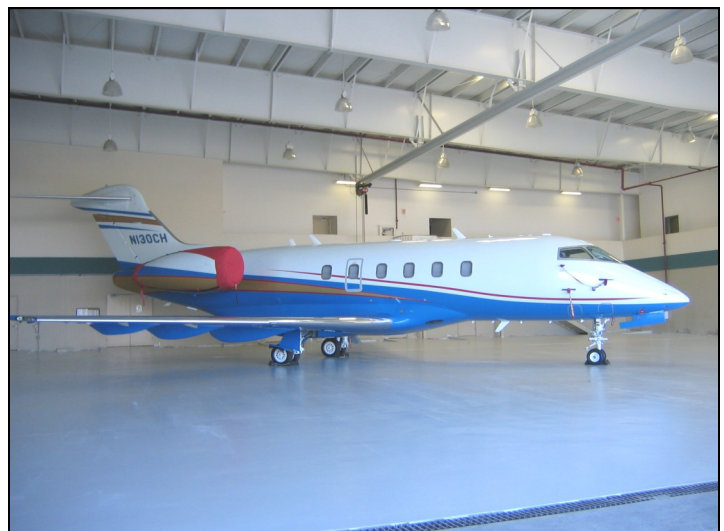
Level-Right WearTop now provides a strong, smooth surface in the hangar.
